**AIR SAFETY
INVESTIGATION DEPARTMENT
TWIN- ENGINE ACCIDENT REPORT**

GENERAL INFORMATION		
ACCIDENT NUMBER	NTSB NUMBER	AIRCRAFT REGISTRATION
11013001	WPR11LA113	N64RJ
AIRCRAFT YEAR / MODEL	AIRCRAFT SERIES	SERIAL NUMBER
1969 / PA-30	Twin Comanche	30-1931
ACCIDENT DATE	ACCIDENT TIME	ACCIDENT LOCATION
01/30/2011	0720 PST	Big Bear City, CA
WRECKAGE EXAM DATE	EXAM LOCATION	
02/02/2011	Aircraft Recovery Service, Pearblossom, CA	
# OCCUPANTS	INJURIES	
1	1 Serious	
OWNER	OWNER ADDRESS	
Tower General Contractors, Inc.	[REDACTED]	
DOR: 05/06/2010	Sun Valley, CA 91352-2061	
OPERATOR	OPERATOR ADDRESS	
Owner/Pilot	[REDACTED]	
INSURER	INSURER ADDRESS	
Arnold & Arnold	[REDACTED]	
	San Diego, CA 92101	
CLAIM REPRESENTATIVE	CLAIM REPRESENTATIVE ADDRESS	
Charles W. (Bill) Arnold	[REDACTED]	
PHONE: [REDACTED]	San Diego, CA 92101

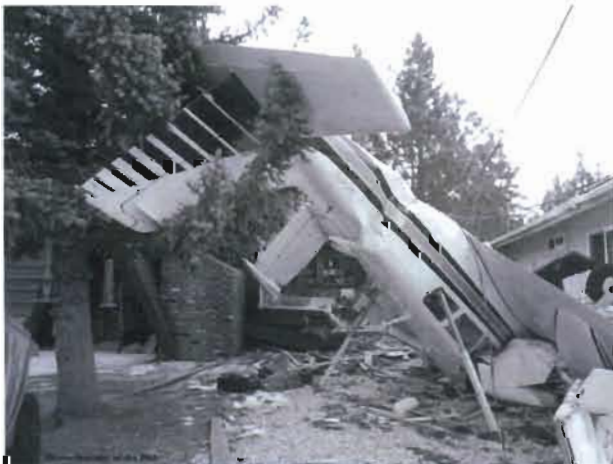
On January 30, 2011, at about 0720 Pacific Standard Time (PST), a 1969 PA-30 Twin Comanche registered as N64RJ impacted between two houses shortly after departing from the Big Bear Airport (L35) in Big Bear City, CA. The impact destroyed the aircraft. The Pilot, Jose Natividad Flores age 55 of Los Angeles, CA and sole occupant received serious injuries.

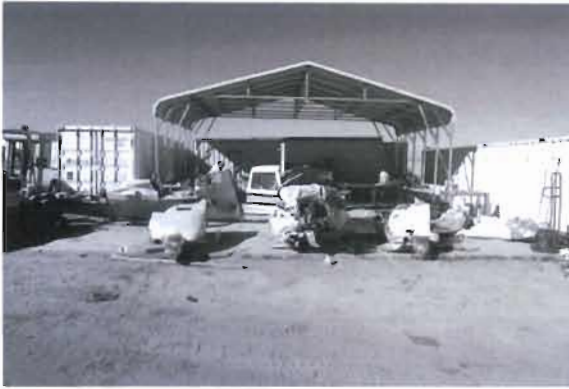
The fuselage, empennage and vertical tail section remained intact.

The aircraft as first viewed was laid out with the major sections of the aircraft in their near normal relationship with each other. The aircraft had been partially disassembled during the recovery process. Both the left and right wing assemblies had been cut off the fuselage at the root area. The left engine was separated from the nacelle. The right engine remained attached to the nacelle but the nacelle section with the AUX fuel tank were separated from the wing. The left and right horizontal stabilator had been disassembled from the tail empennage section.

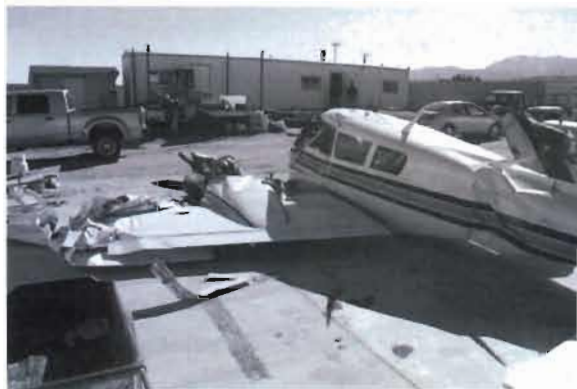
Left Wing

The left wing exhibited extensive impact damage outboard of the engine nacelle. The wing was partially broken outboard of the flap surface and was mostly destroyed. The flap surface remained attached to the wing and was in the retracted position. The aileron remained attached by the inboard hinge only and was folded back under the inboard wing surface. The landing gear remained attached. The gear retract system was cut by the retriever and the gear was up in the wheel well but was free to extend by hand.

The left main fuel tank contained fuel on site and was captured by the retriever during the recovery process. The left auxiliary bladder style tank was not observed. The left wing tip tank was destroyed by impact.

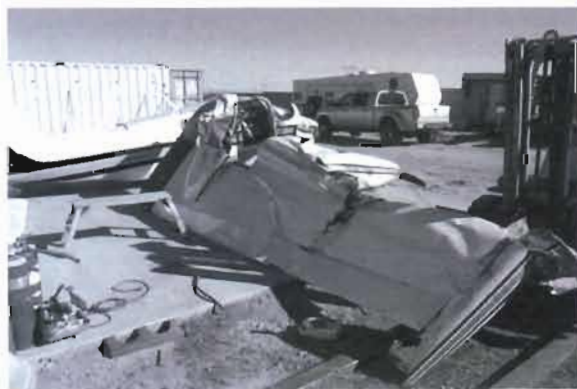
Right Wing

The right wing exhibited aft crushing along its entire leading edge from the nacelle area to the tip. Both the aileron and flap surface remained attached to the wing. The engine nacelle, with attached engine separated from the wing. The landing gear remained attached and was in the down and locked position.

Right main fuel tank was not breached. The retriever reported that about 5 gallons of fuel was defueled from the tank during recovery process. The right auxiliary bladder style fuel tank has a small hole.

The right wing tip tank was destroyed by impact.

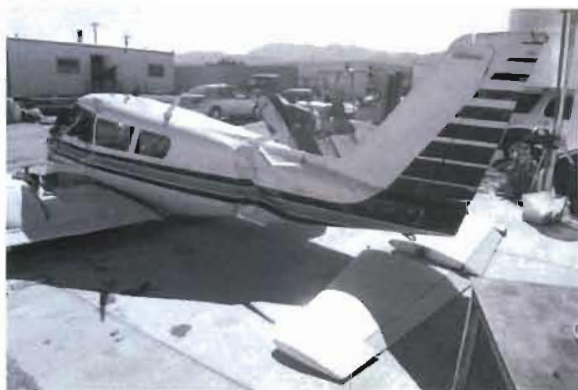
Empennage

The empennage section was mostly intact. Skin wrinkling was present on the left side aft of the cabin bulkhead and forward of the vertical surface. The vertical and rudder surface remained attached and were mostly undamaged. The left and right horizontal stabilizer were removed by the retriever during the recovery process but appeared mostly undamaged.

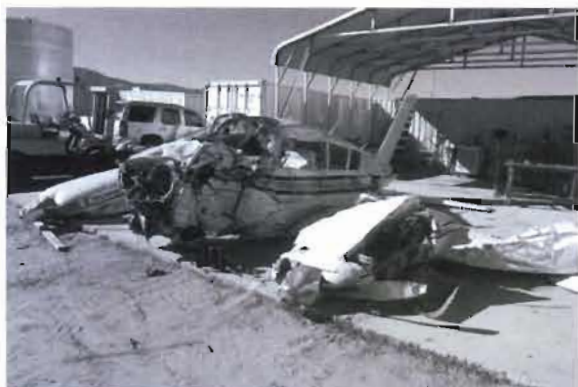
Fuselage

According to the on scene FAA inspector, continuity of the flight control systems was established on site to all movable flight controls surfaces up to the forward cockpit section prior to the aircraft being disassembled during the recovery process.

The forward fuselage nose section and forward instrument panel section sustained extensive ground impact damage. The nose section exhibited extensive crushing signatures to the left side skins forward of the firewall section. The forward cabin

and instrument panel exhibited crushing damage around the entire enclosure.

The landing gear switch was in the gear down position. The landing gear retraction system indicated that the gear was in the down position. The nose landing gear remained attached but had sustained impact damage and was destroyed. The flap transmission assembly was found in the flaps retracted (up) position.
